Summary of EPA Surface Water Sampling of Select Metals Results to Date

Gold King Mine Blowout

August 7, 2015

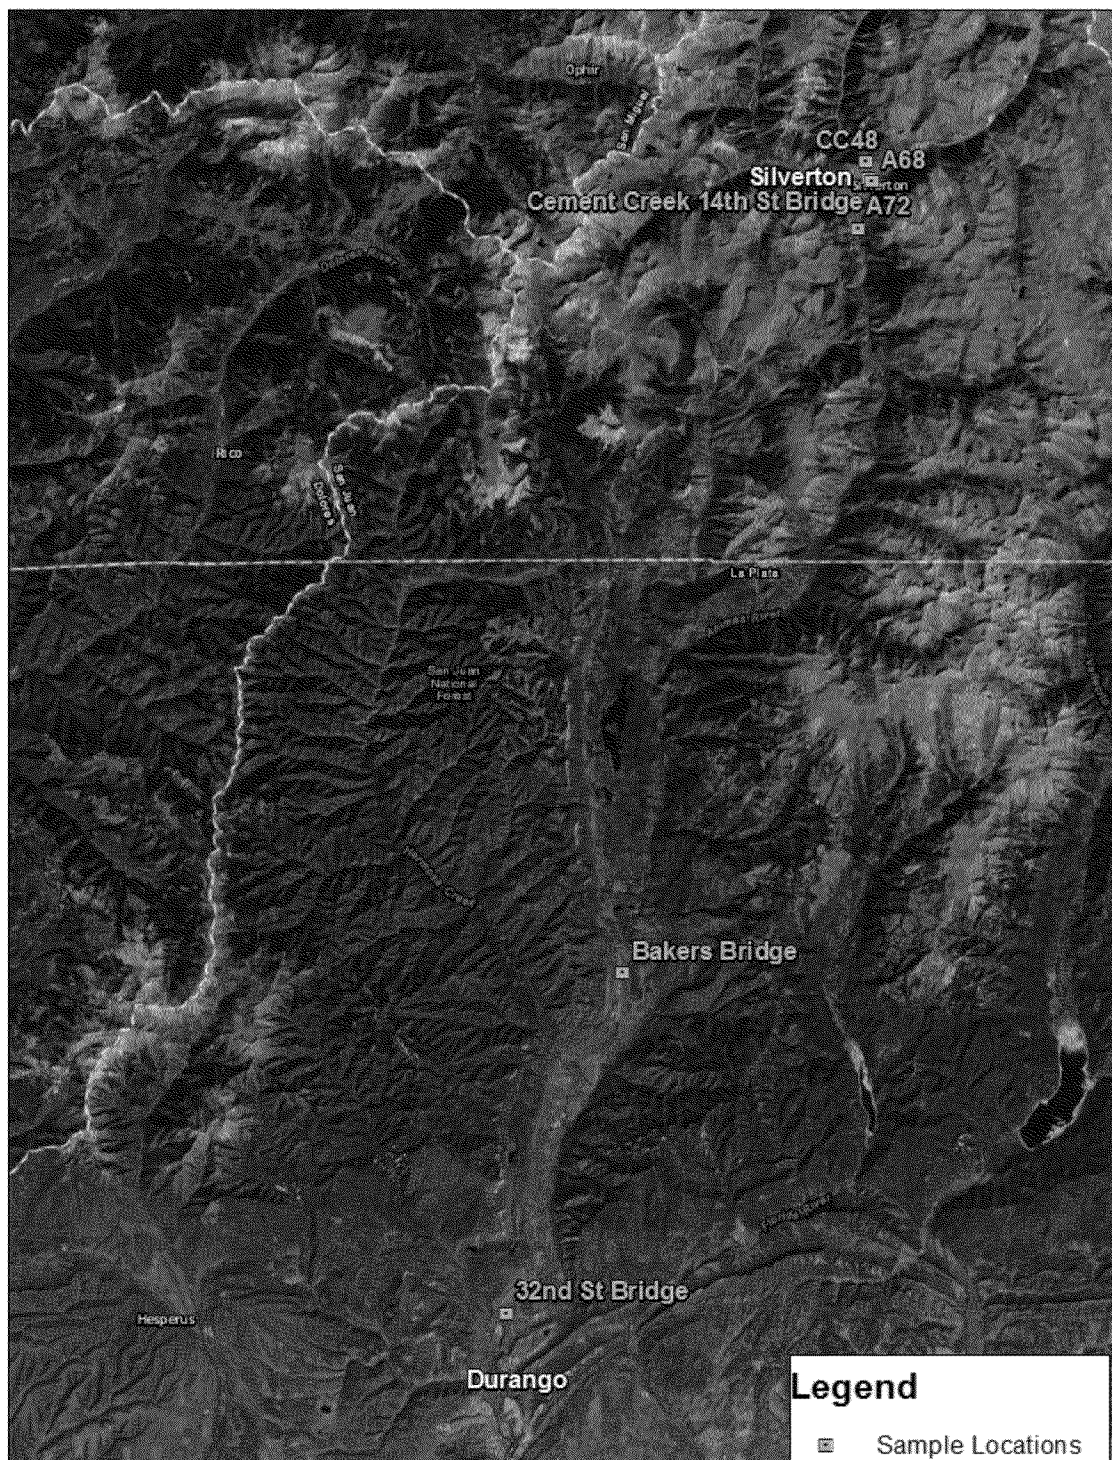
Attachment 1: EPA Sampling Locations

EPA initiated a sampling effort on August 5, 2015, to assess the impacts of the blowout at the Gold King Mine near Silverton, CO. Surface water quality samples were collected from 7 locations (see Attachment 1). Two of these locations were on Cement Creek and 5 of these were on the Animas River in Colorado. These locations were selected based on the fact that an historical dataset already exists at these locations and they will serve thus as good indicators of conditions before, during and after the event. Data depicted are the results of samples collected over two days. These samples were delivered to the lab on August 6th. Results were available and evaluated on August 7th.

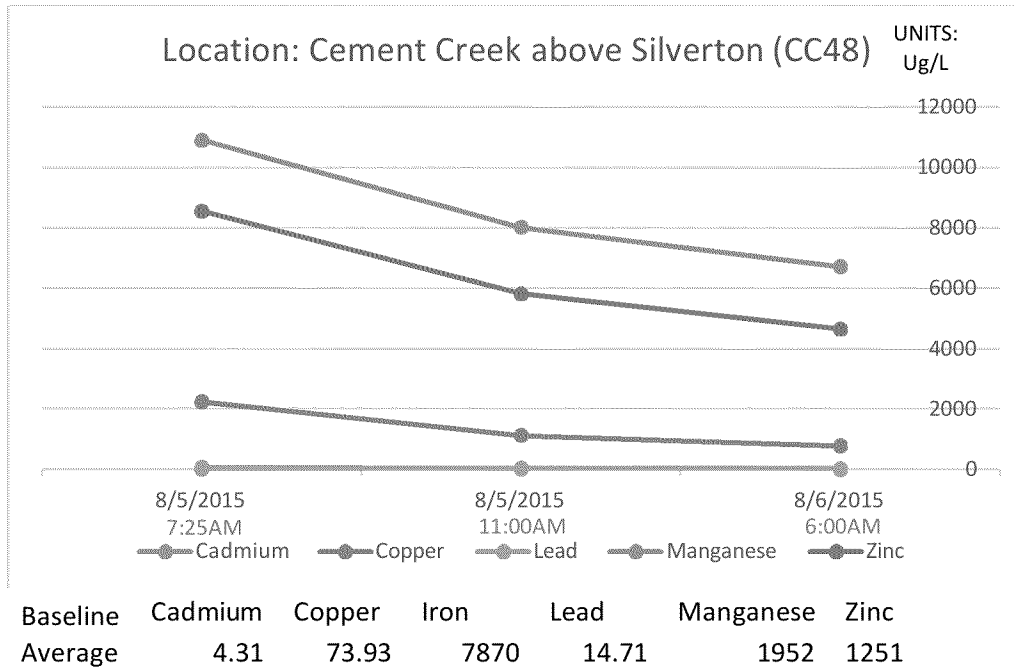
The first graph provides data on Cement Creek, the downstream from the blowout (CC48). Concentrations throughout the first day following the blowout are above historical averages for the copper, lead and manganese. However, the graphs demonstrate a decrease in those concentrations over the 24 hour period.

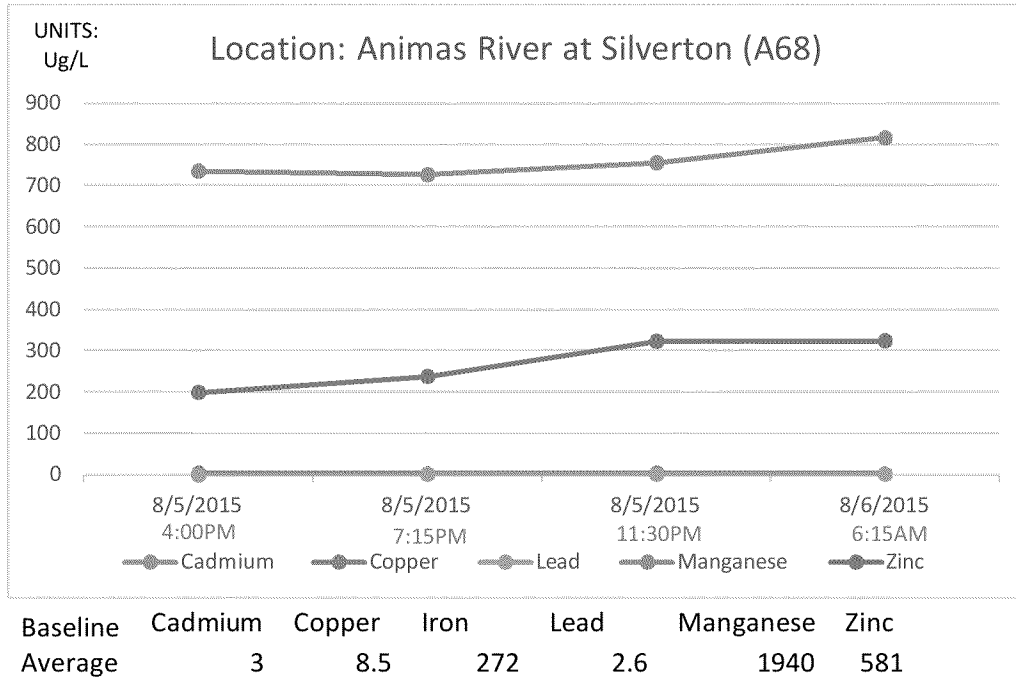
The second graph provides data on the Animas River above the town of Silverton (A68) and above Cement Creek. This graph demonstrates relatively unchanging metals concentrations that are at or below historical averages.

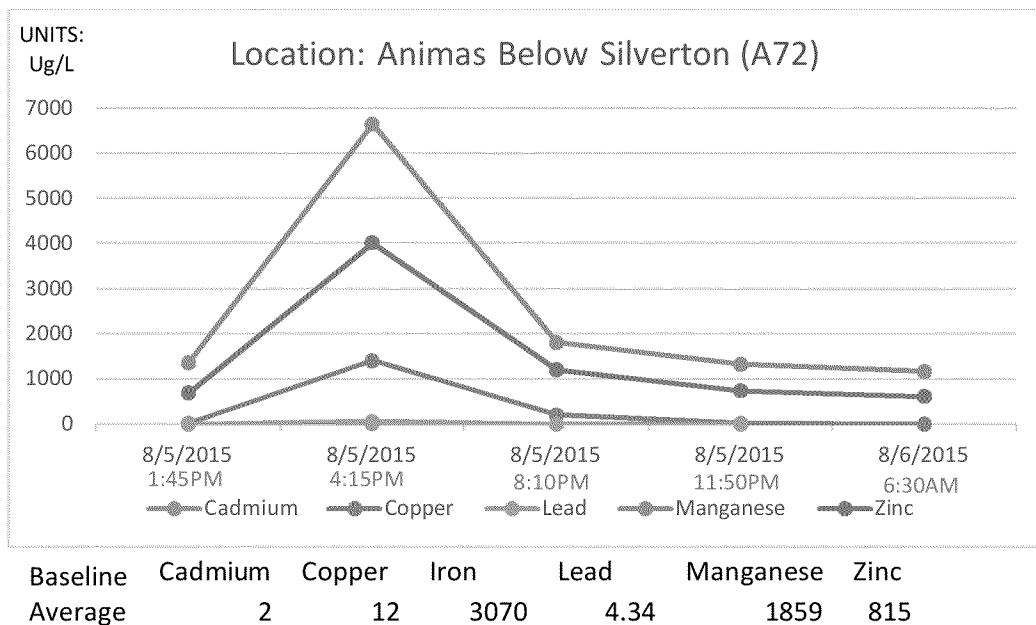
The third graph demonstrates the data from the Animas River just below the town of Silverton (A72). The graph shows an initial spike in metals concentrations with levels returning to historical averages by the morning of August 6, 2015.

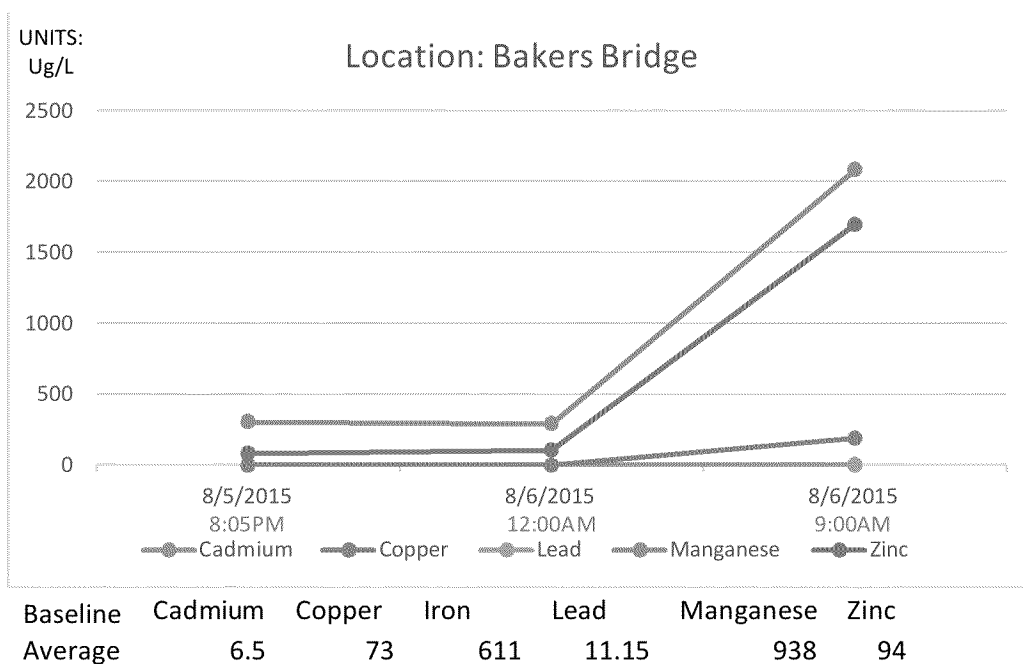
The fourth graph demonstrates the data from Bakers Bridge on the Animas River just above Durango, CO. Since this location is about 20 miles from Silverton, the metals concentrations are

increasing above historical averages. But, it is believed that subsequent data collection activities will demonstrate a decrease in concentrations similar to those seen at upstream locations.

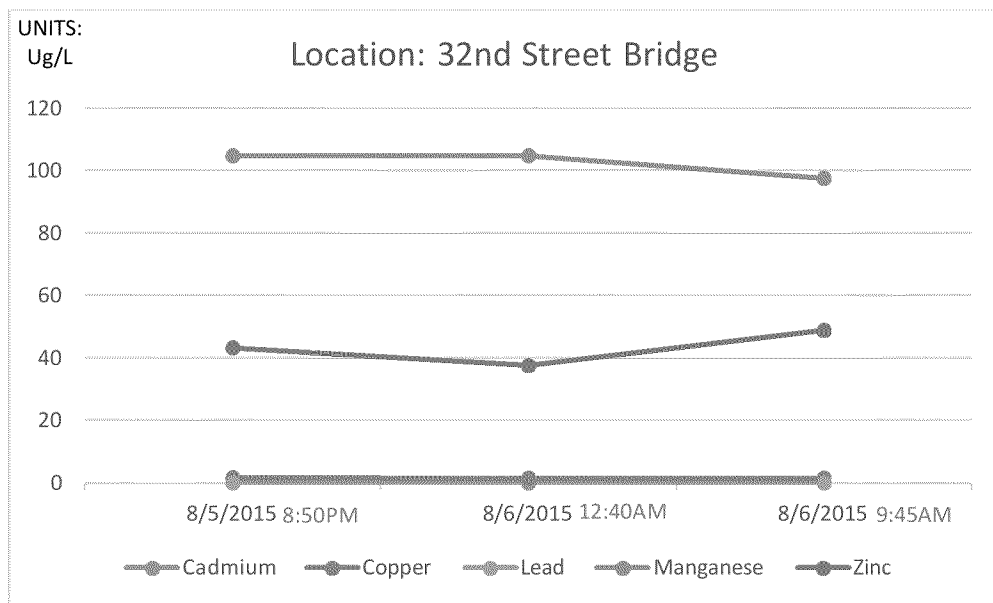
The fifth graph is of the 32nd Street Bridge sampling location. At the time the samples were collected, it does not appear that the contamination had yet reached this sampling location.
